Manhole Inspection Summary

Manhole # S49K__043MH

Insp Date: **3/27/08 1:07 PM**

Location Address: **646 S Gover Lakewood**

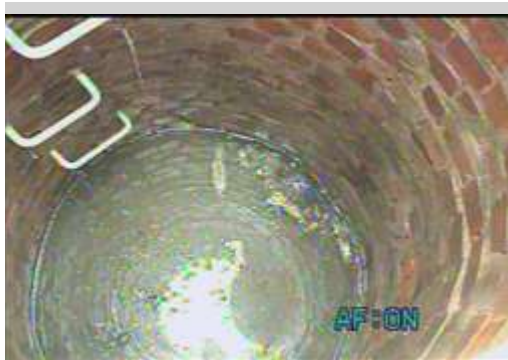
Defect 5

evidence of surcharge (from previous inspection visit)

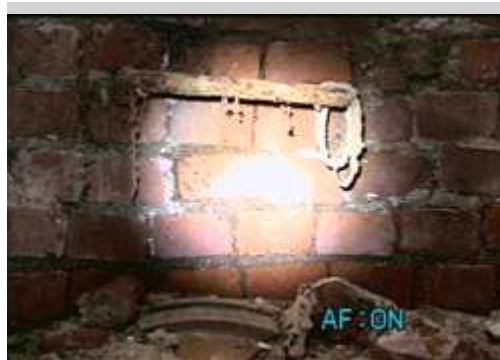
Defect 4

☒ **Evidence Of Surcharge** Depth: **9.3** (ft.) ☐ Active Surcharge Present

evidence of surcharge

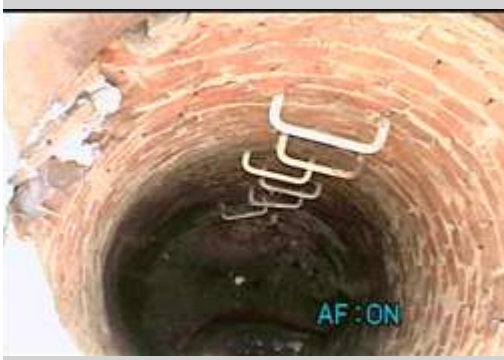
Defect 3

Count: **7** Missing: **0** ☒ **Corroded**

cor.steps

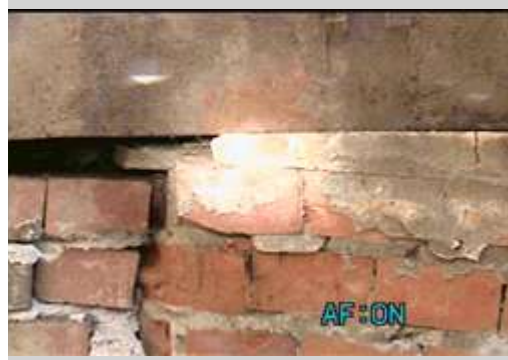
Defect 2

Condition: ☐ Sound ☒ **Cracked** ☐ Root Intrusion ☒ **Loose Brick** ☐ Deteriorated

frame adj cracked, loose bricks

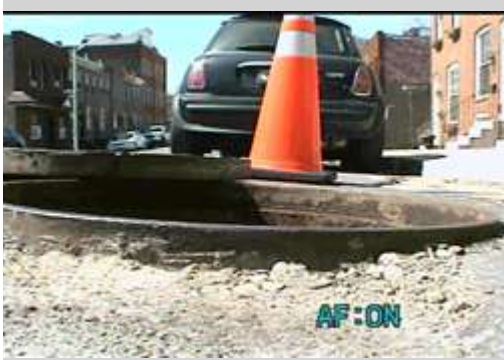
Defect 1

Diameter: **32** (in.) Length: **0** (in.) Dist A/B Grade: **1** (in.)

above grade

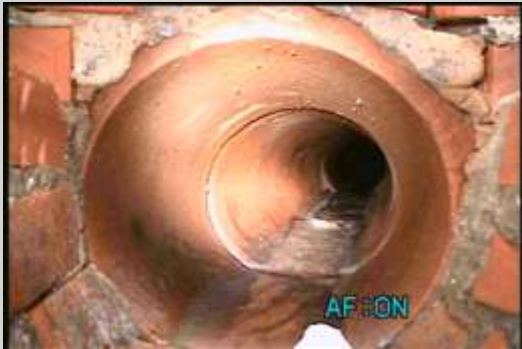
12 O'Clock Outflow

15 in. Circular Gravity Sewer
Pipe Out @ 12 O'Clock

Pipe Material: **Clay** ☐ Pipe Lined

Invert Depth: 11.33 (ft.) Flow Characteristics: **Fast**

Infiltration: **None** Pipe Seal Cond: **Unknown**

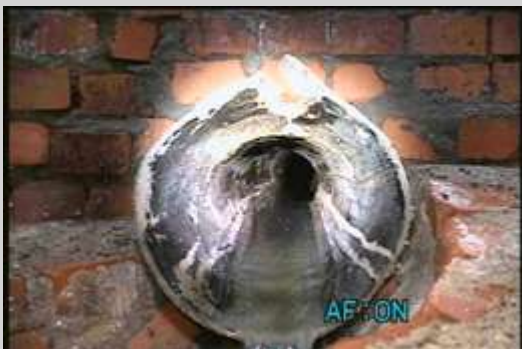
4 O'Clock Inflow

15 in. Circular Gravity Sewer
Pipe In @ 4 O'Clock

Pipe Material: **Clay** ☐ Pipe Lined

Invert Depth: 11.00 (ft.) Flow Characteristics: **Fast**

Infiltration: **None** Pipe Seal Cond: **Unknown**
